**INDIVIDUAL PROPERTY/DISTRICT
MARYLAND HISTORICAL TRUST
INTERNAL NR-ELIGIBILITY REVIEW FORM**

Property/District Name: Woodcock Farm/Sandy Point Survey Number: WO-11

Project: Woodcock Farm Golf and Housing Development Agency: F/COE

Woodcock House

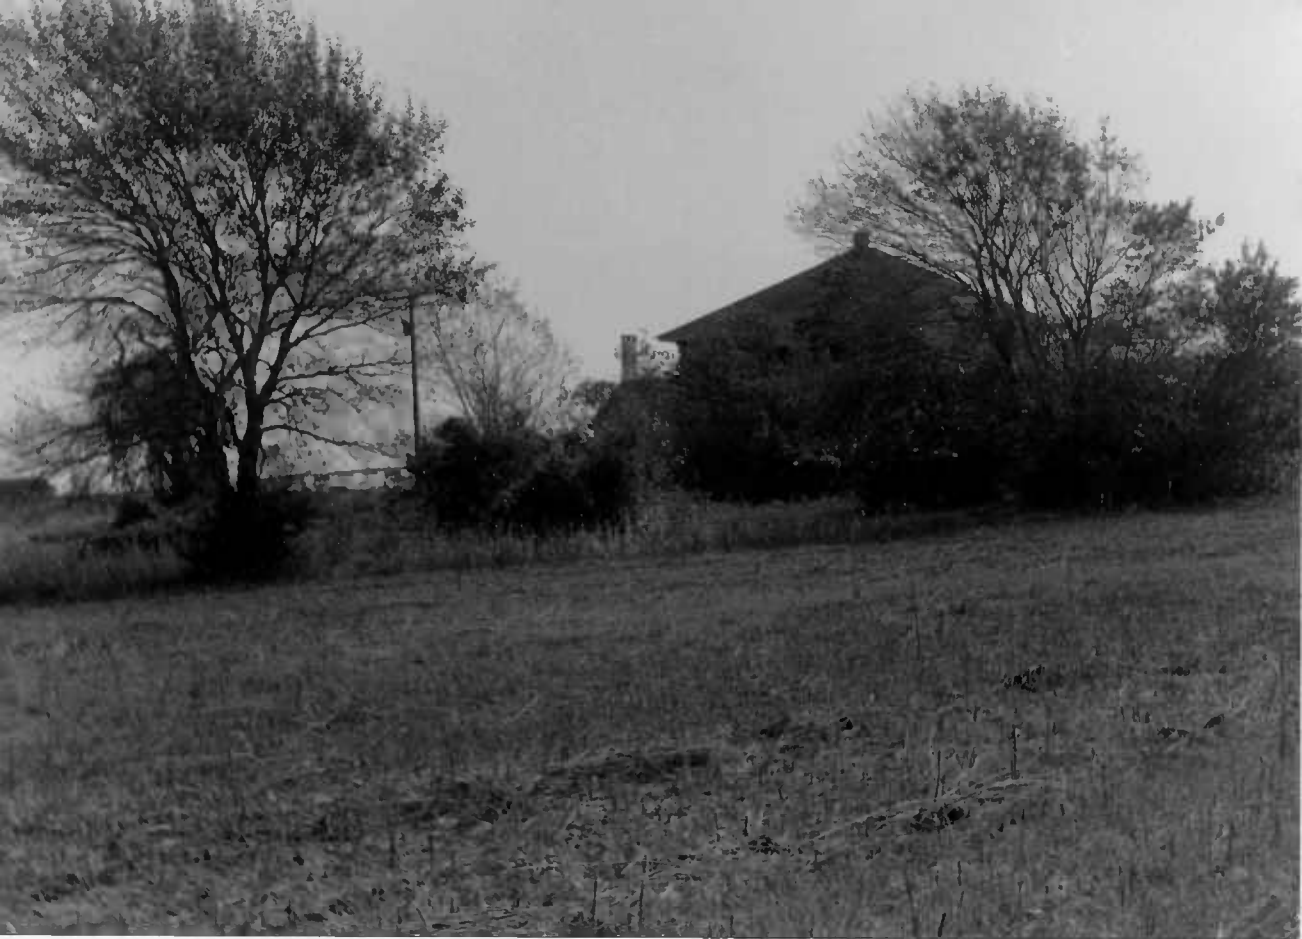
1/17

1. View of the Woodcock farmhouse from a location and angle similar to the early photo
2. View of the south wall, from roughly the same angle as the early photo

View from SW

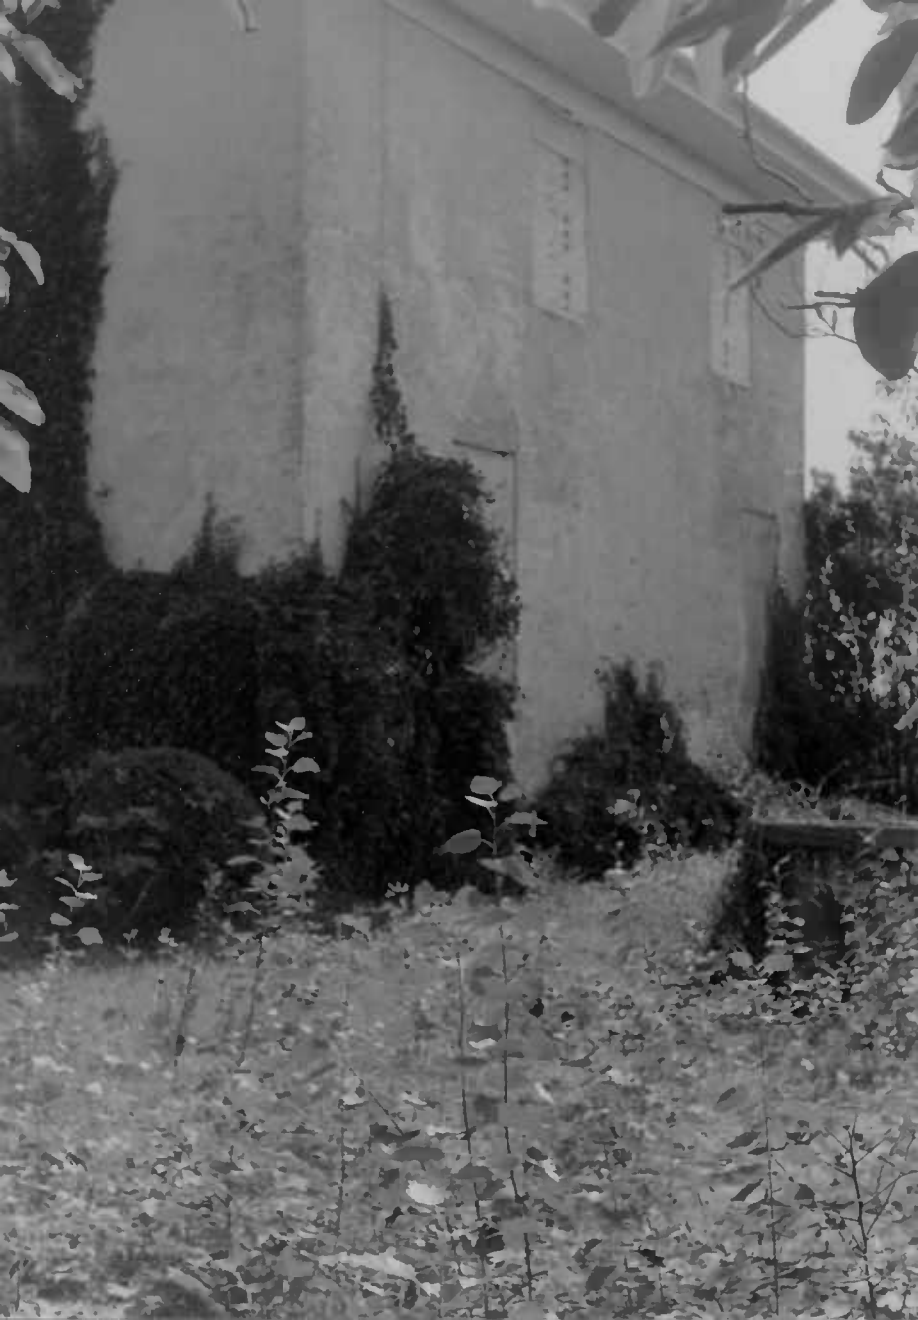
2/17

South wall
from southwest

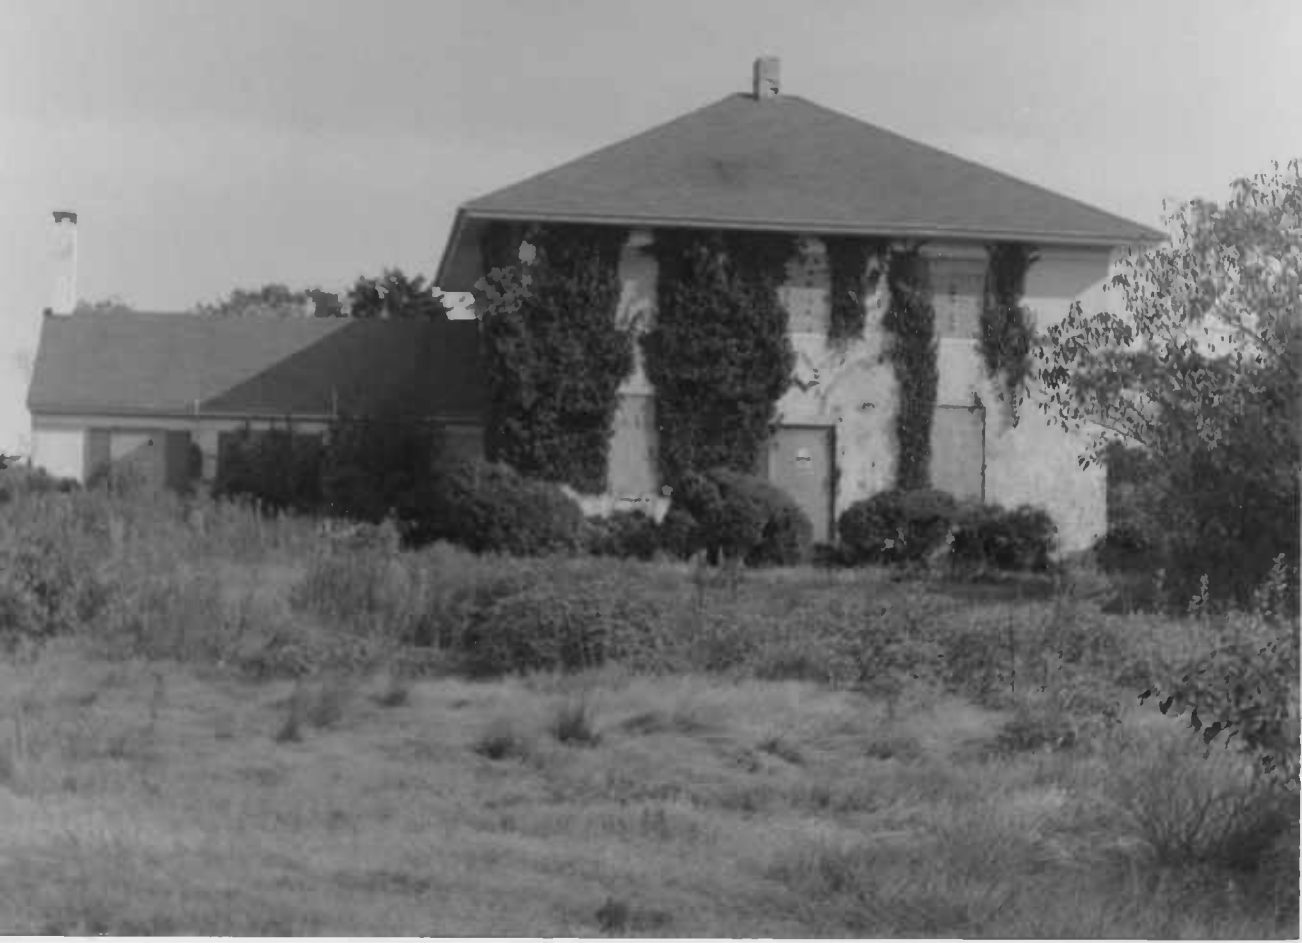
3/17

West elevation

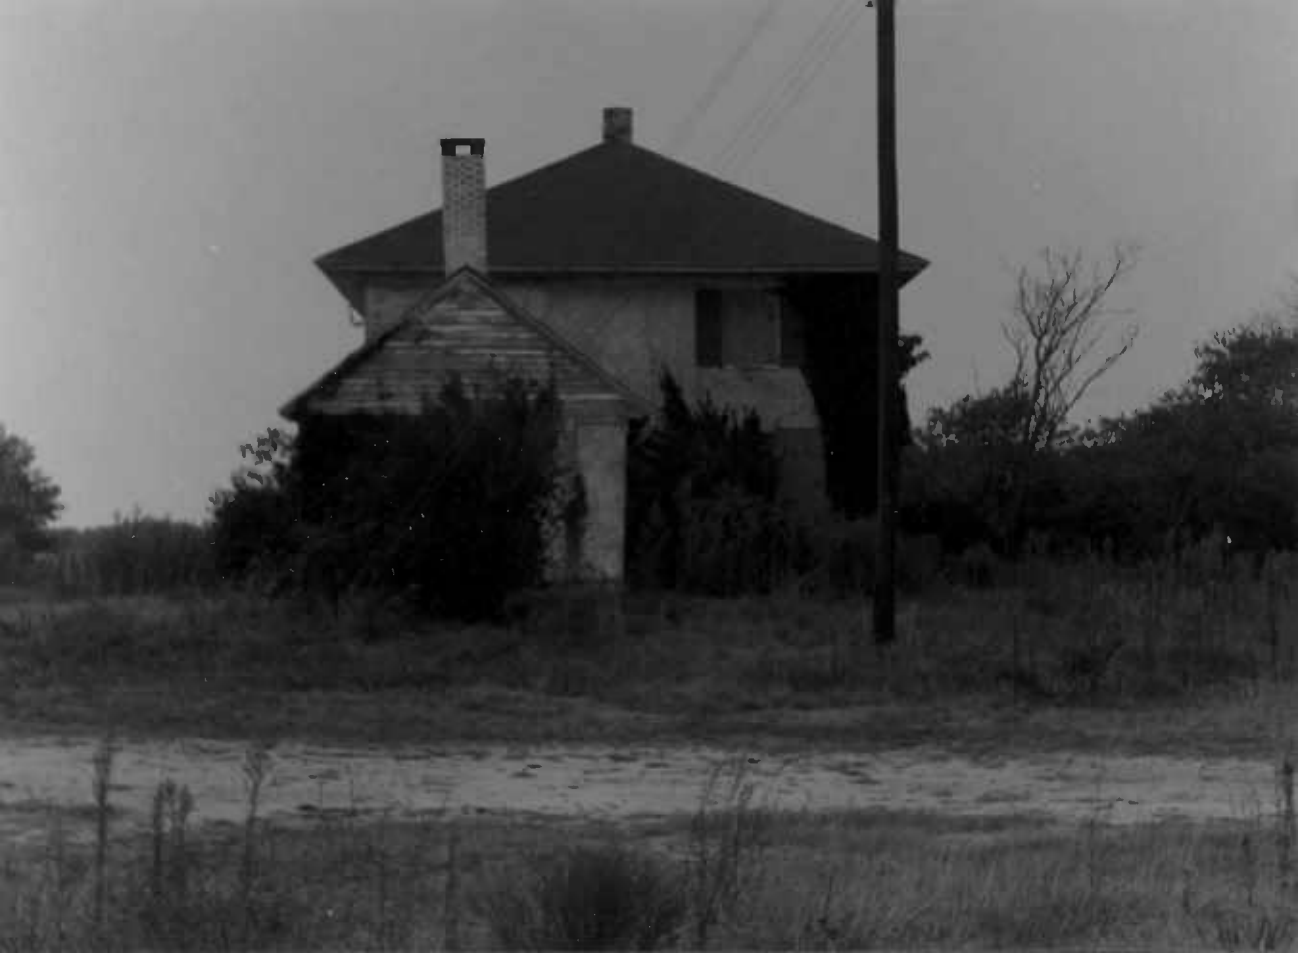
4/17

North Elevation

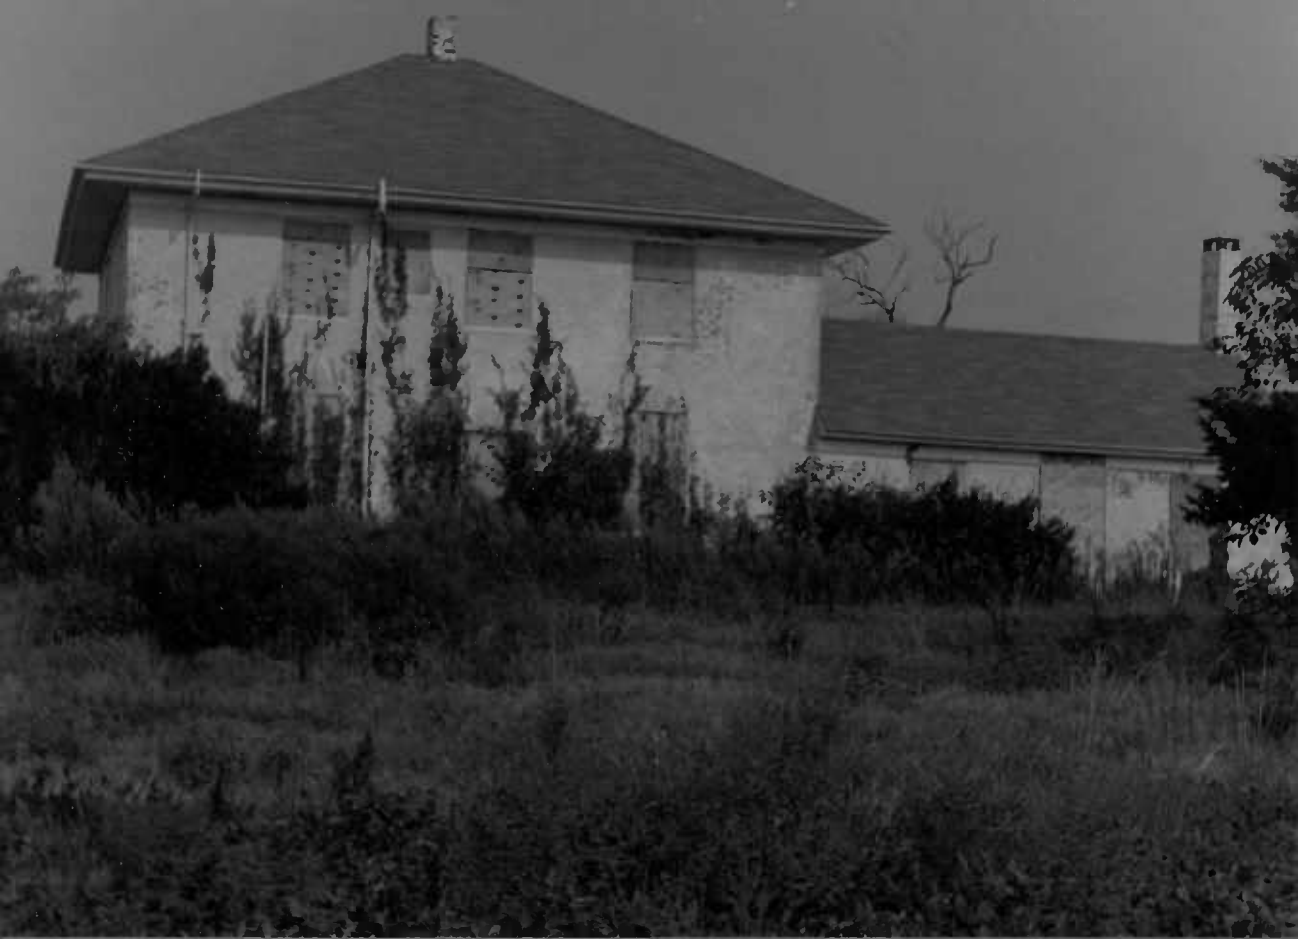
5/5

East Elevation

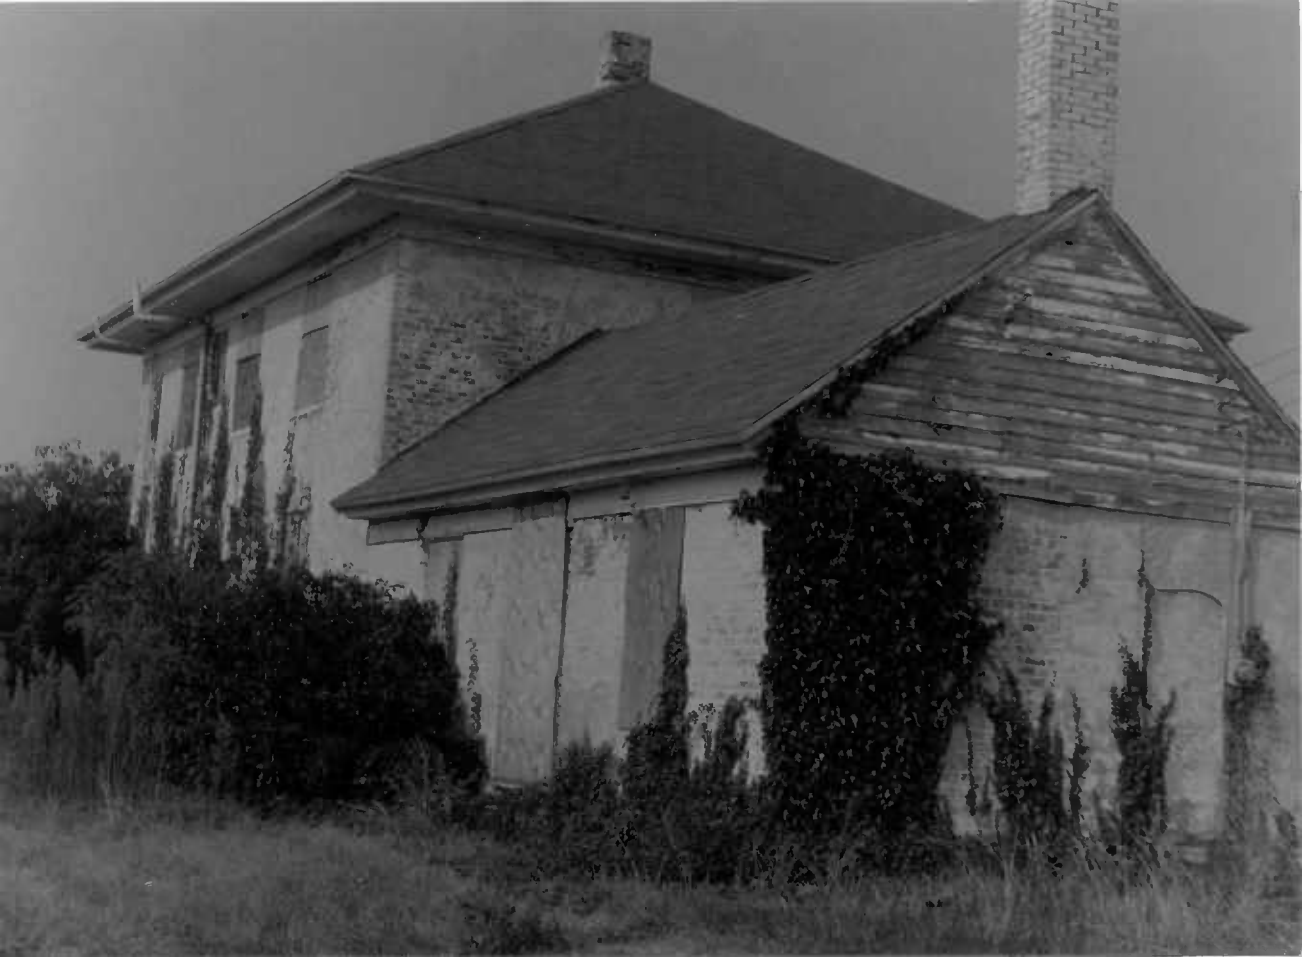
The kitchen wing apparently was added during the first half of the nineteenth century. Its west wall is stuccoed, but part of the stucco is missing from the east wall. A patch of apparently original brickwork has been exposed, to exhibit relatively smoother bricks laid in Flemish bond with narrower joints than the bricks of the main house. The northeast corner of the kitchen wing, including the chimney, is modern, with machine-made stiff-mud brick laid in common bond with simple concave mortar joints. The interior of the kitchen wing consists of a modern kitchen, a passage, and a boiler room.

3. West Elevation
4. North Elevation
5. East Elevation
6. View of the kitchen wing from the northeast
7. Detail of the center of the south wall, showing Flemish bond above and below water table, with glazed headers

North end,
From Northeast
6/17

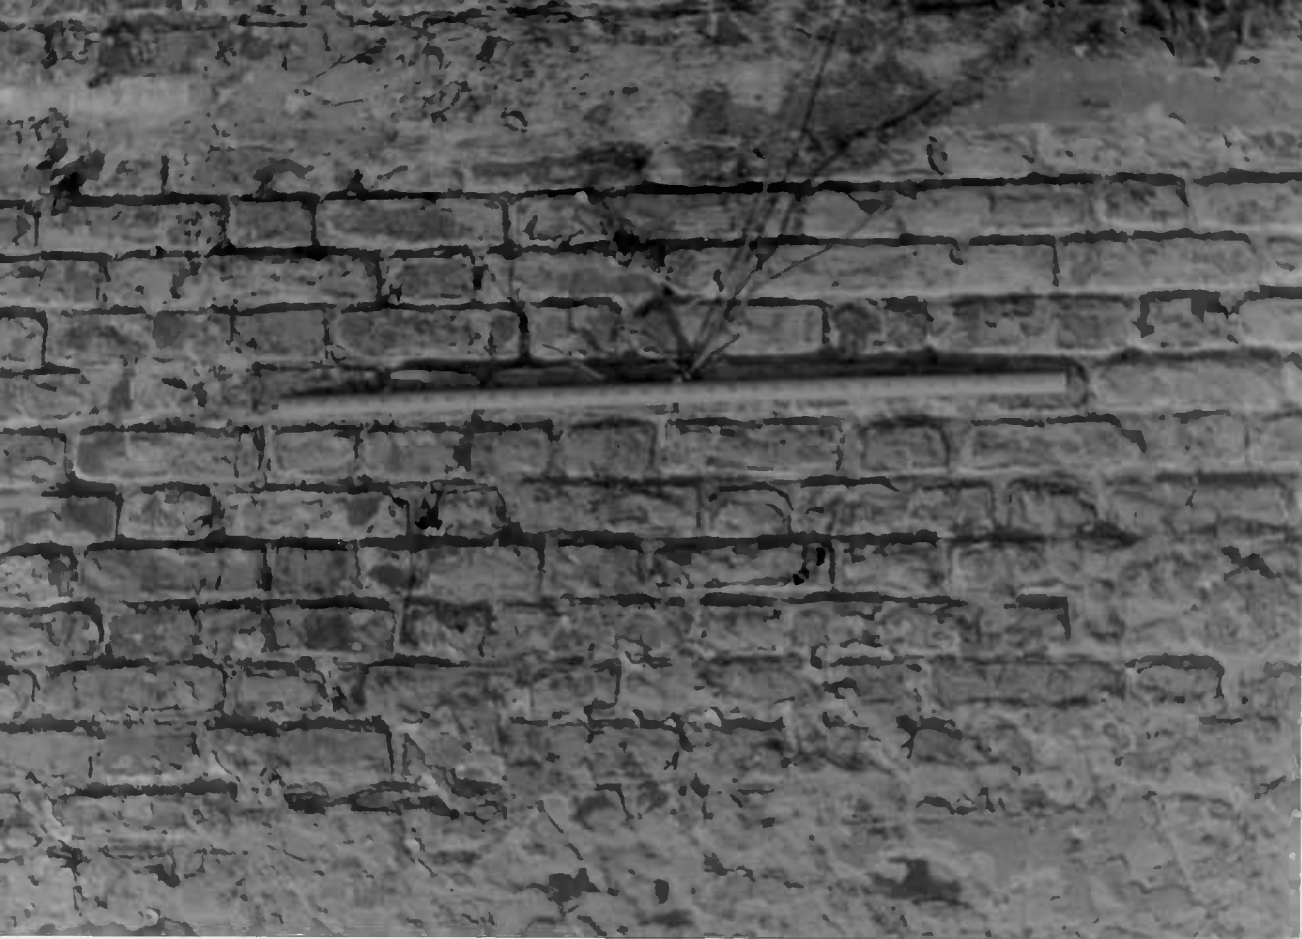
7/17

The two-story brick house is nearly square (33'3" by 37'7"), with a one-story wing to the north. Symmetrical three-bay ashlar stuccoed facades appear on the east and west. Fenestration on the sides is irregular, however. Brickwork on the main house is Flemish bond. On the north and south walls, where stucco is missing, glazed headers can be seen, possibly in a decorative pattern.

Detail, south wall

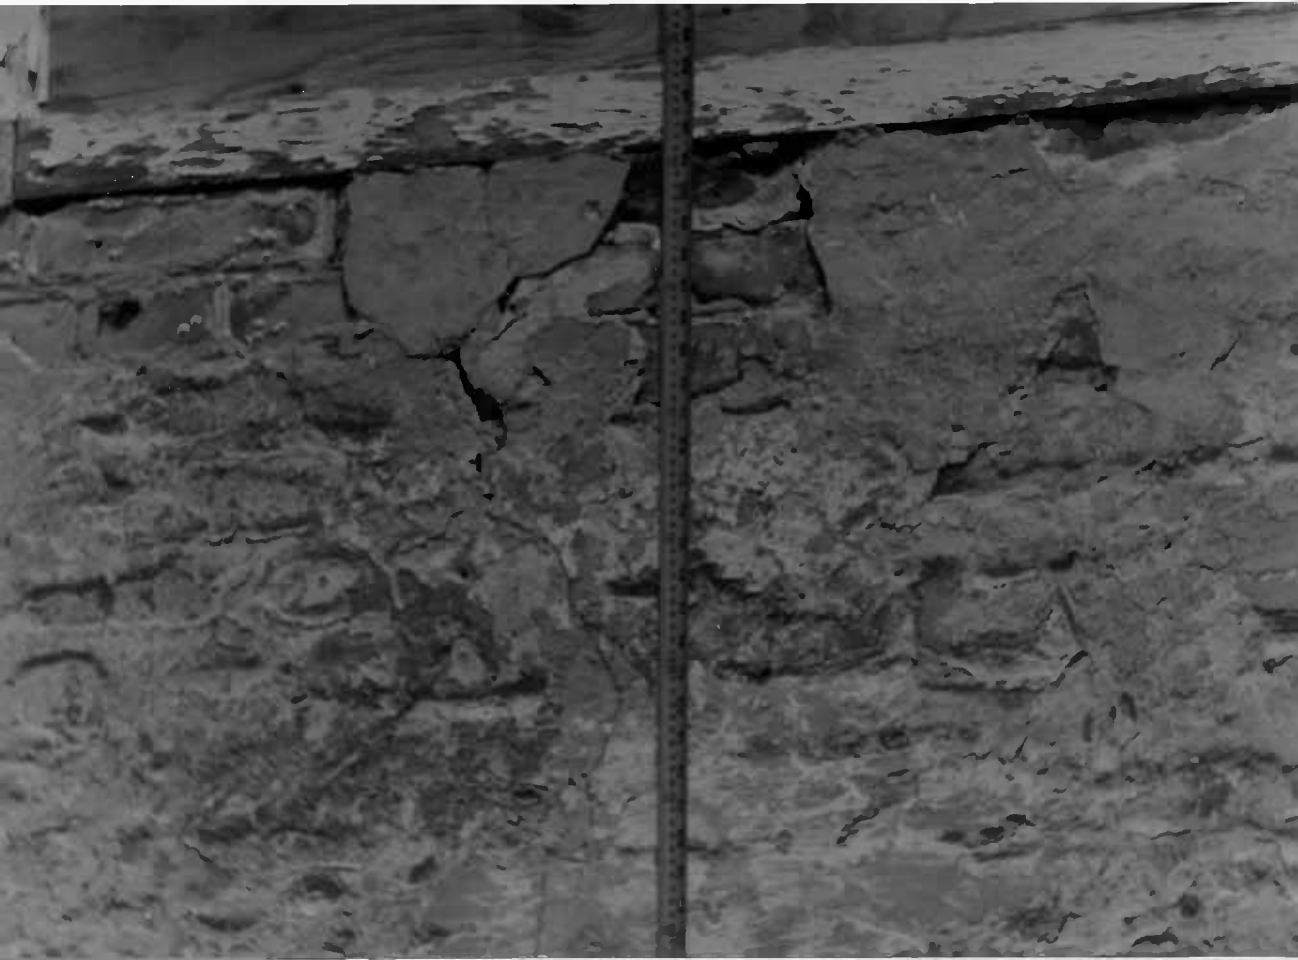
8/17

8. Right window, second floor, south wall, showing patches in stucco
9. View of the dairy, as seen from the house
10. Southeast corner of the dairy
11. View of the dairy from the east, with the house in the background

Detail, S. wall

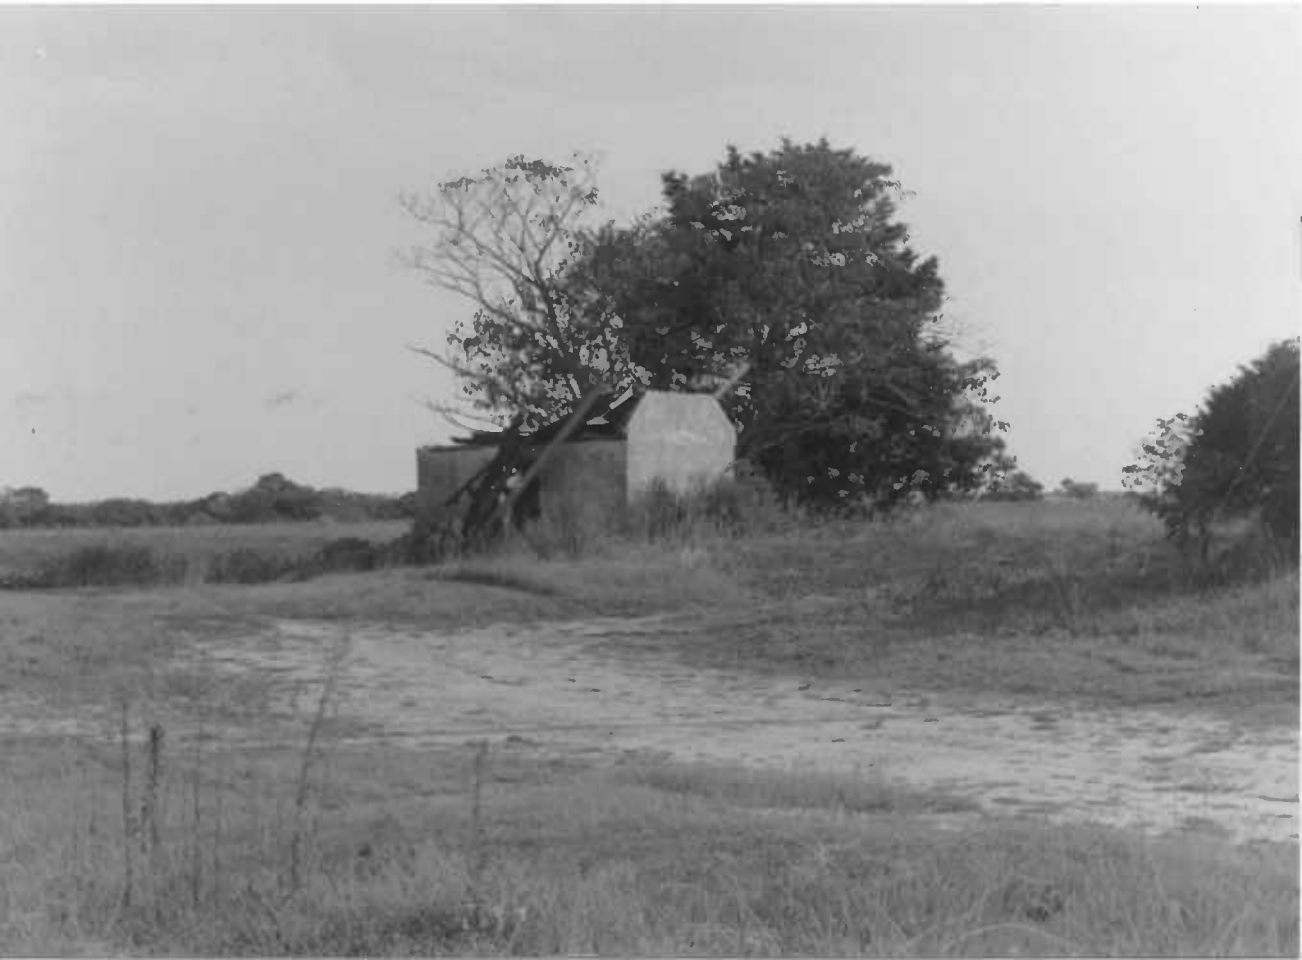
9/17

The eighteenth-century dairy is a stuccoed brick building, not aligned to the main house, standing to the east, on the edge of the domestic yard, roughly 15' by 12'. Its gable roof has fallen, and its door and window trim is missing.

Dairy from west

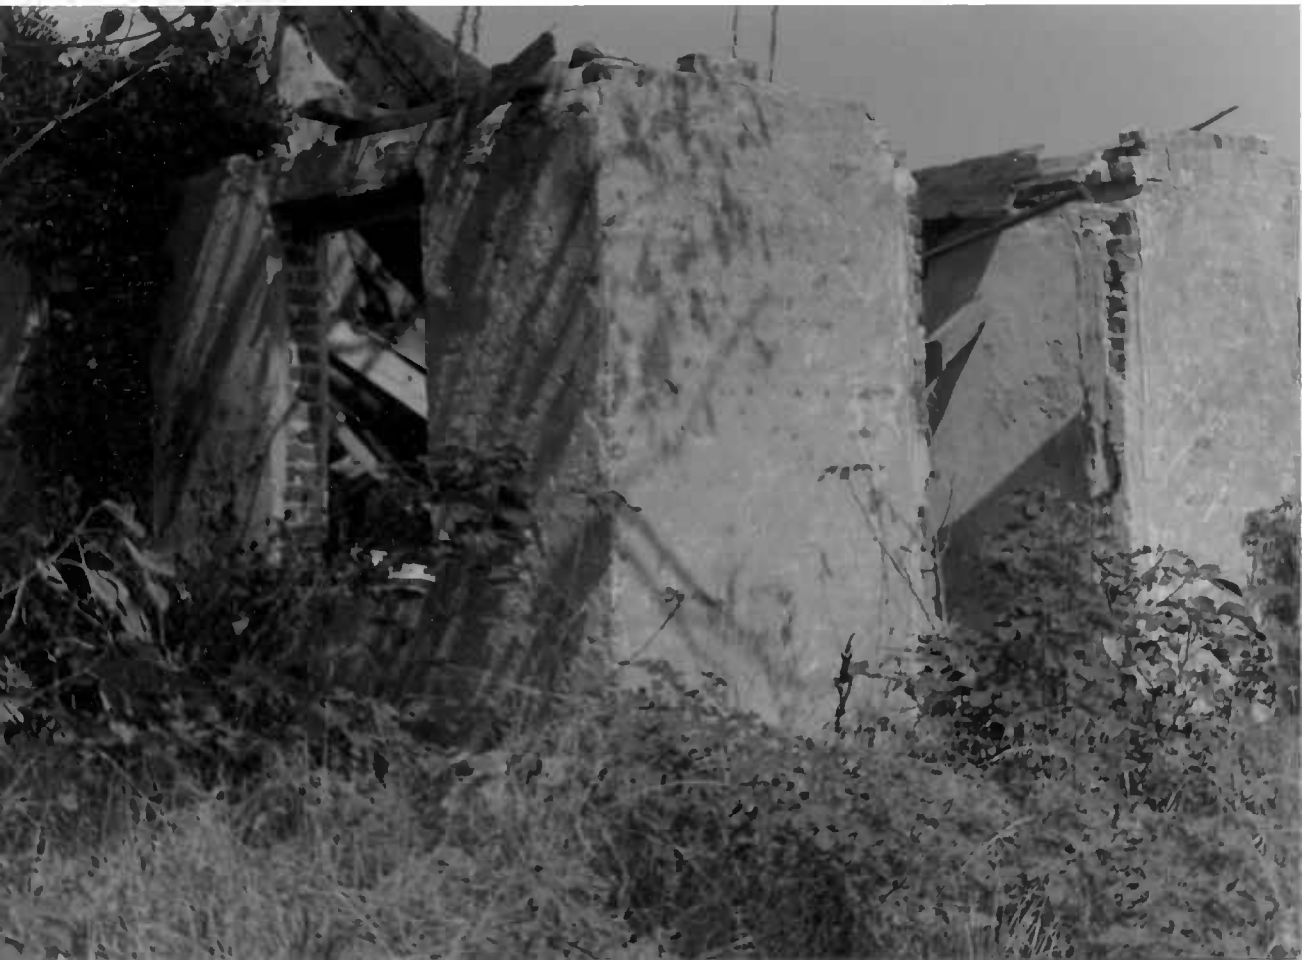
10/17

Southeast
Corner of Dairy

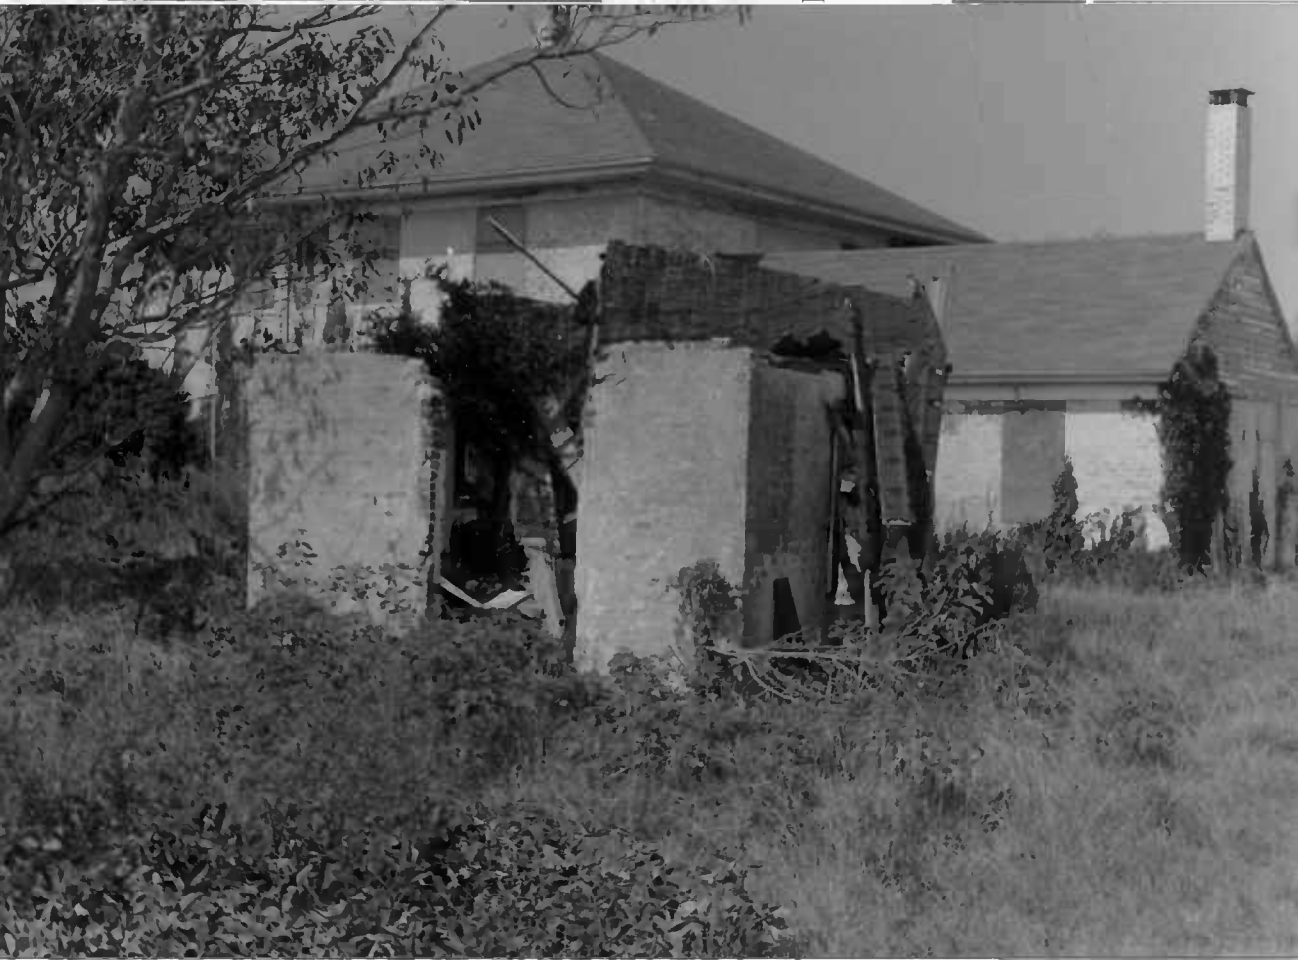
11/17

Dairy from East

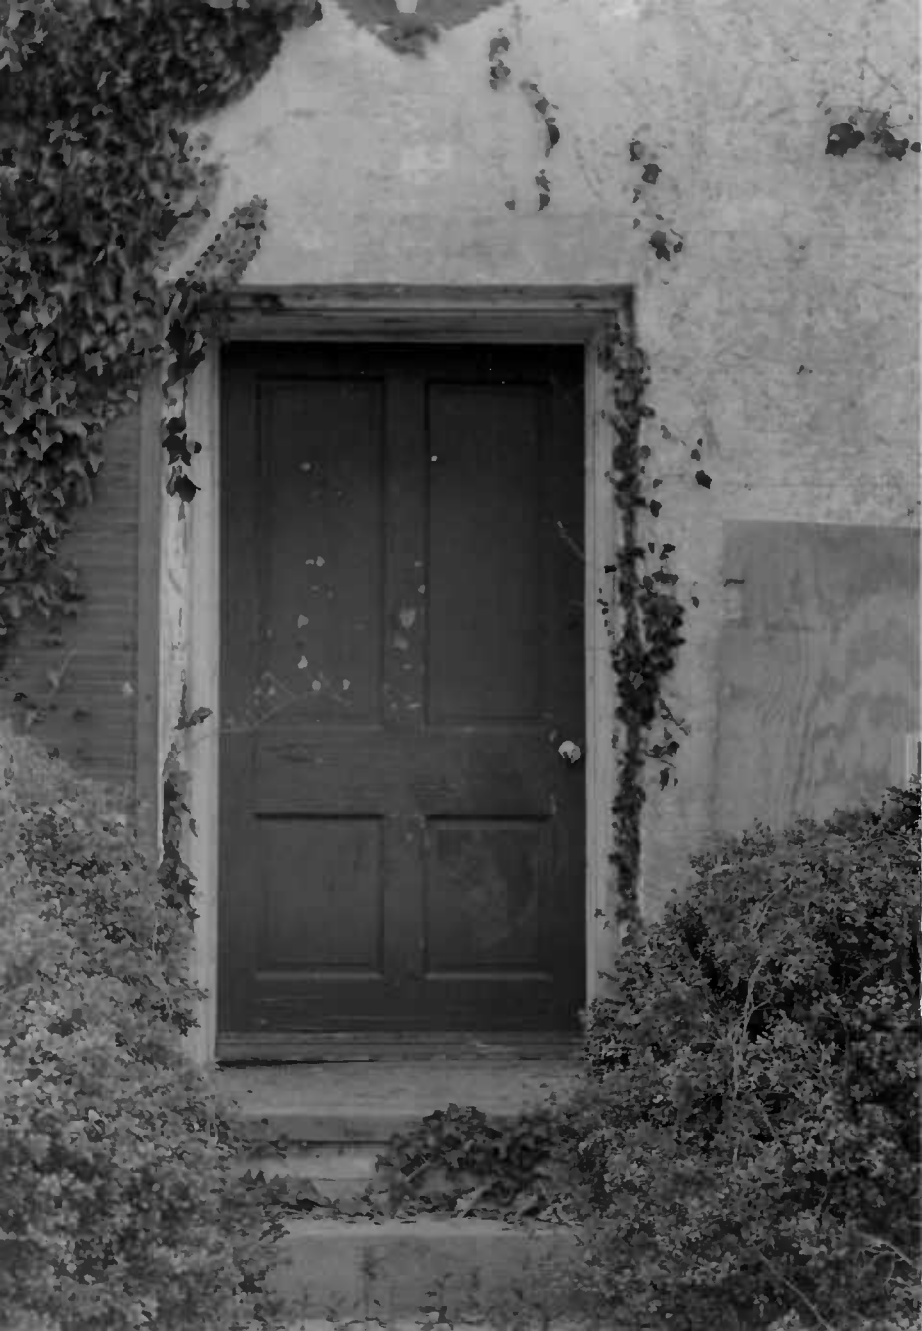
13/17

According to an old photograph reprinted by Touart (1994:242), there was a portico on the west facade, which has been replaced by a simple concrete step. Also missing is the gable roof, which featured a "Tudor" kicked eave treatment. The photograph also shows a pair of relatively large attic windows, which are an unusual feature in this locality.

West door

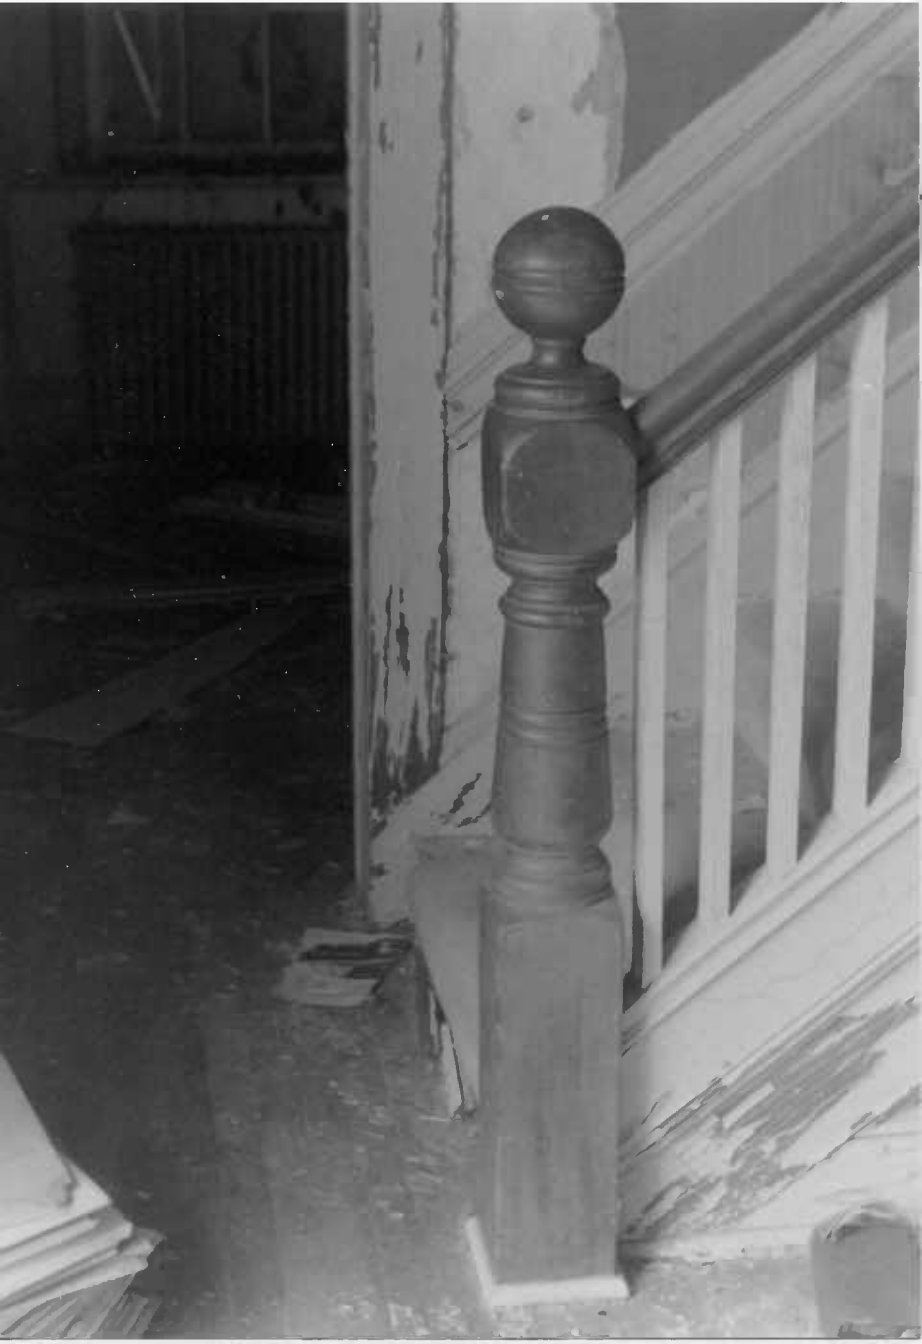
14/17

A staircase, three feet wide and open on one side, gives access to the second floor from a passage next to the east entry. The turned newel post indicates early-twentieth-century date for this feature. The plastered wall below the stair contains sawn lath and hair binder.

12. View from the dairy, down the lane toward the bay
13. West Doorway
14. Newel post near the east doorway
15. Plasterboard central wall with original brick partition wall exposed

Newel Post

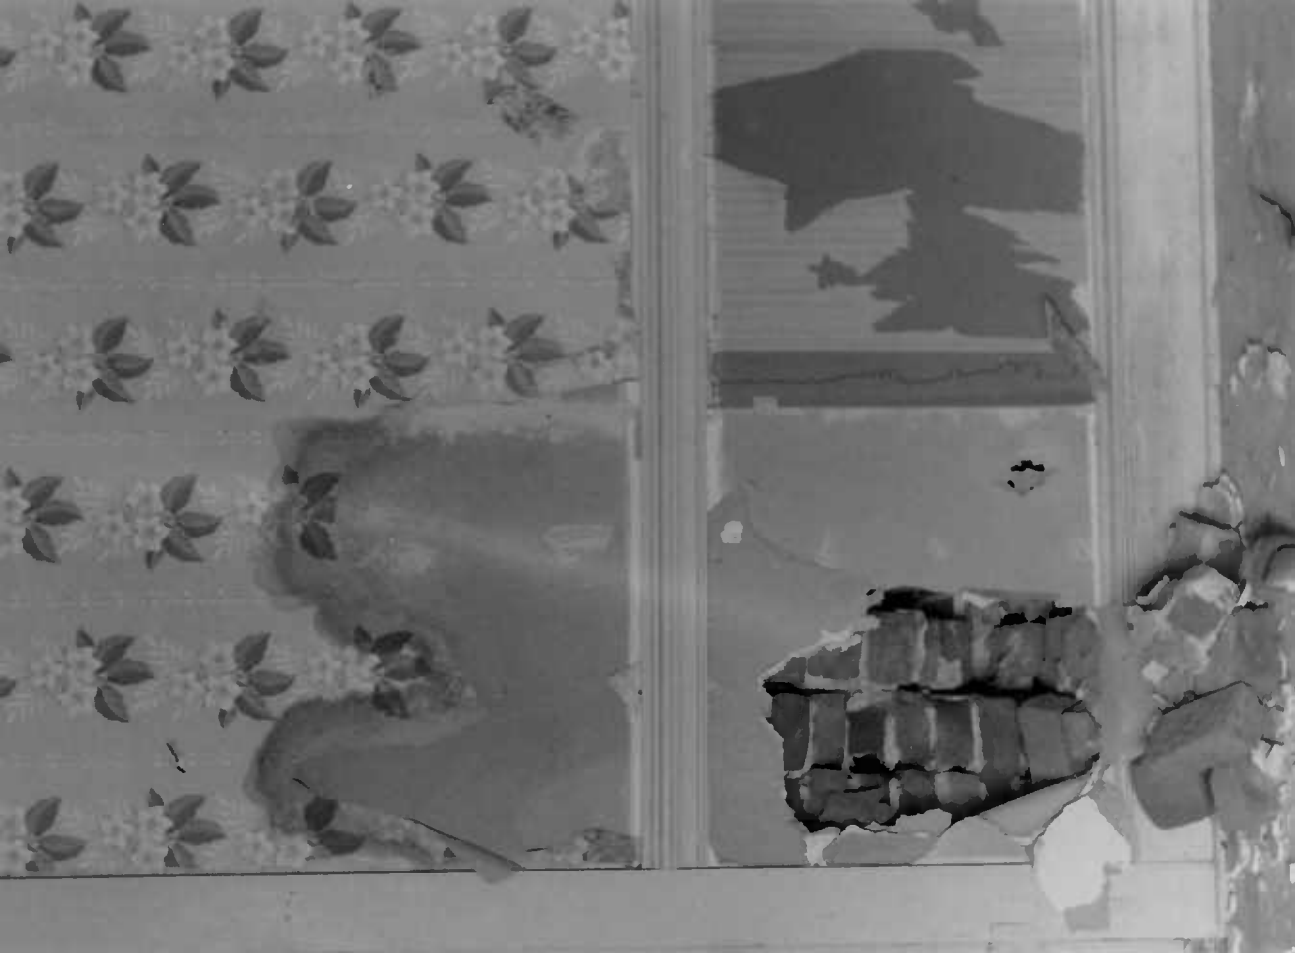
15/17

Bisecting the first floor is a sheetrocked stud wall constructed of modern "dimension" lumber, 3.5 inches thick. The ends of this wall are near the locations of the former end chimneys, which are supposed to have served corner fireplaces.

Partition and
Chimney at
Center, first floor

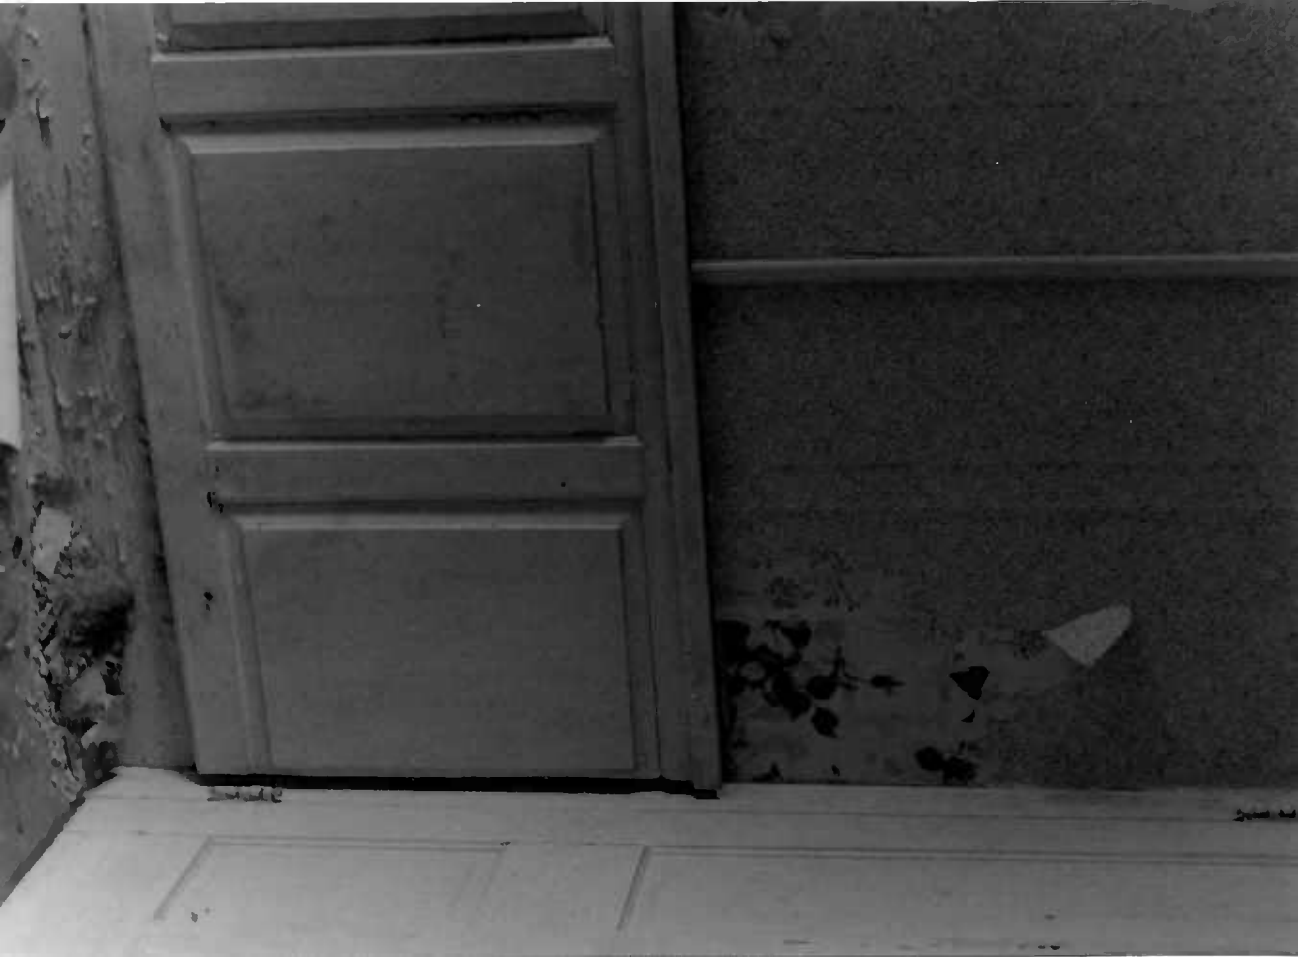
16/17

16. Raised panelling attached to the central brickpartition wall, showing junction with the plaster board central wall, where the panelling has been cut

Dado alleged
to be from

Genesar

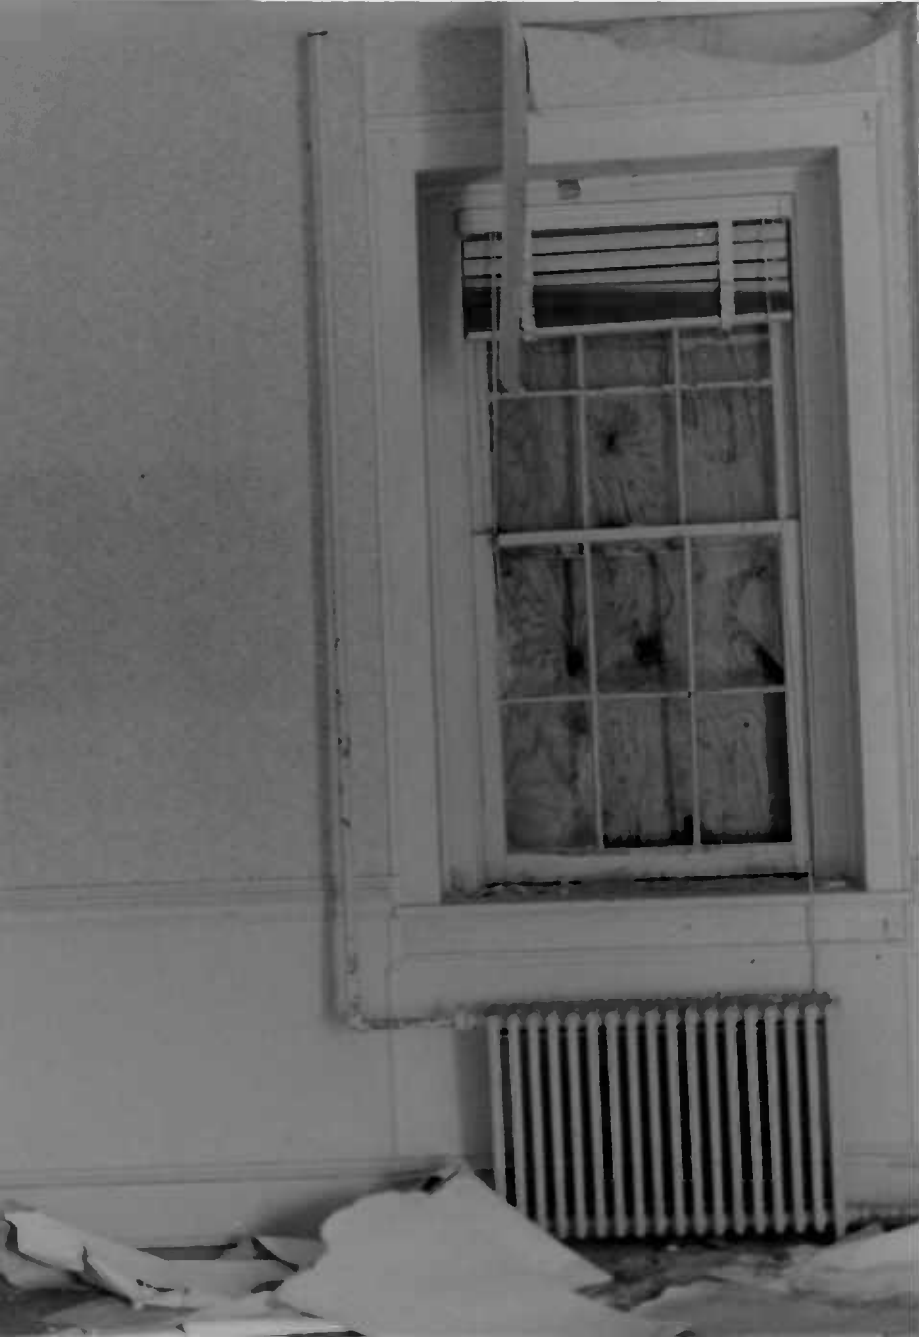
17/17

17. Window on south wall of southwest room

West window
South 1st Floor
